LAKE WYNONAH DAM

PHASE I INSPECTION REPORT NATIONAL DAM INSPECTION PROGRAM

JULY 1978

LAKE WYNONAH DAM
SCHUYLKILL COUNTY, PENNSYLVANIA
NATIONAL I.D. NO. PA 00702

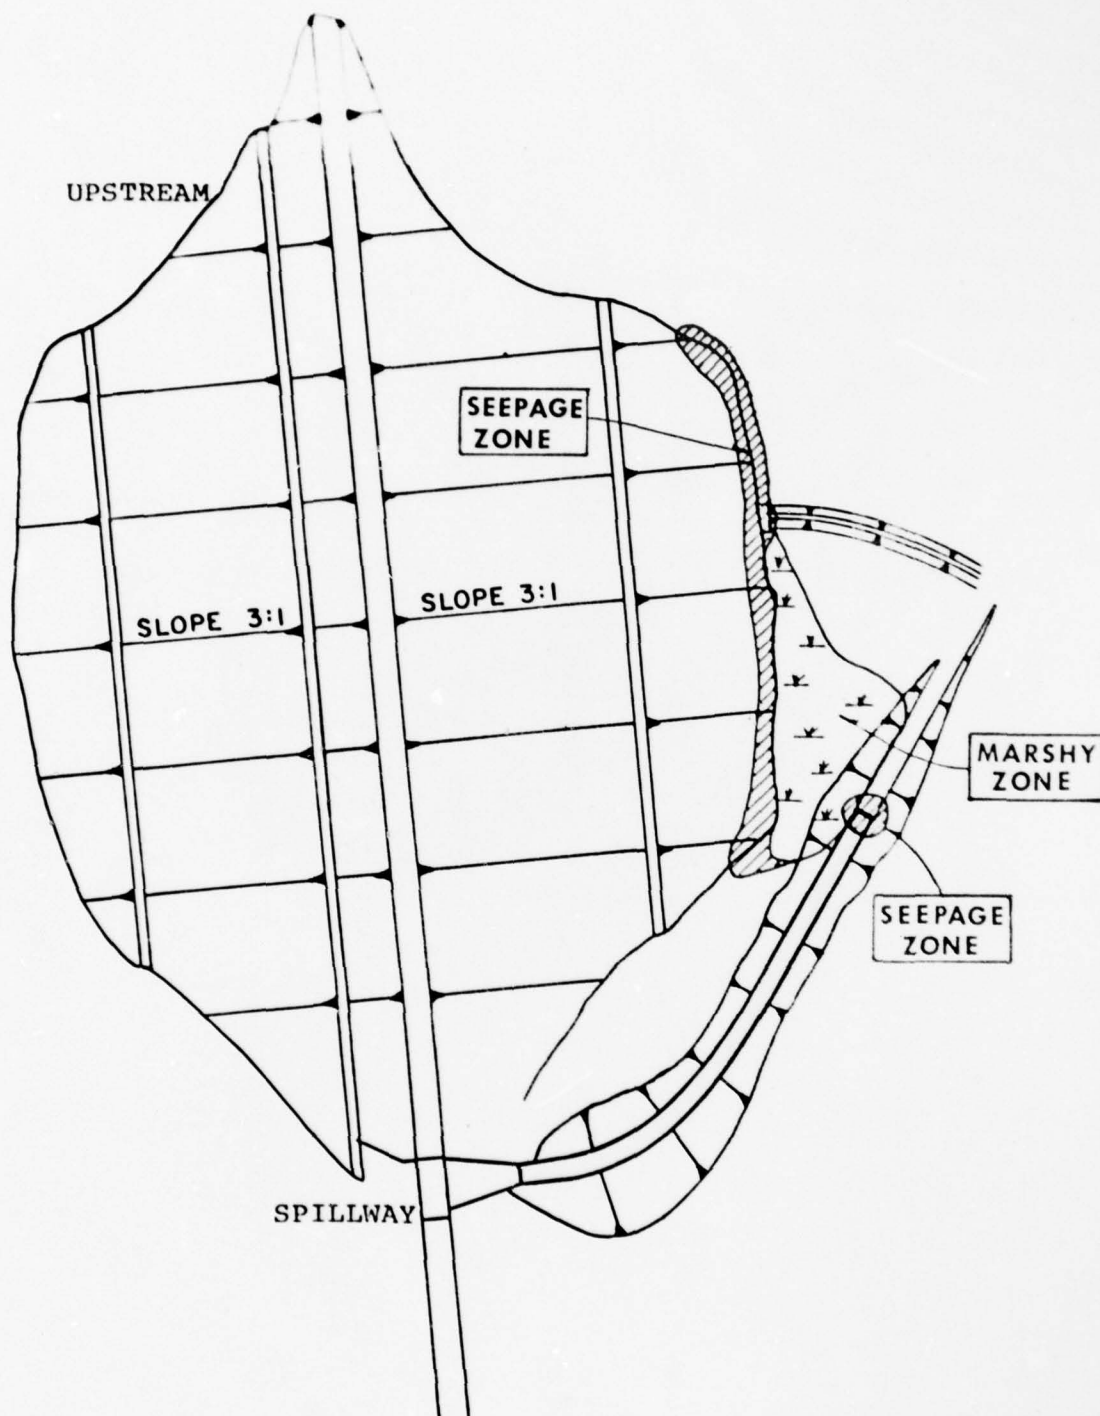
SEEPAGE LOCATION PLAN
LAKE WYNONAH DAM
SHEET 5a OF 11

As shown on Sheet 5a, Appendix B, standing water was observed below the downstream toe on the right side of embankment. It is assumed, based on previous inspections, that this standing water has existed for several years and has remained unchanged. Considering the pervious downstream embankment materials and the blanket drain, seepage is expected to occur along the base of the dam and, perhaps, up the slope for a small distance. This seepage does not appear to indicate hazardous conditions, although it should be monitored for rates of change or increases in turbidity.

The visual inspection disclosed no evidence of apparent past or present movements to indicate instability of the dam. The wet areas noted on Sheet 5a, Appendix B are to be expected considering the type of materials and drainage system incorporated in the embankment.

Note: Due to the type of seepage occurring (sheet flow), the quantity of flow could not be accurately estimated.

4. The seepage presently discharging around the pond drain outlet works and adjacent areas should be monitored for increases in flow or changes in turbidity. If conditions worsen, necessary remedial measures should be taken.

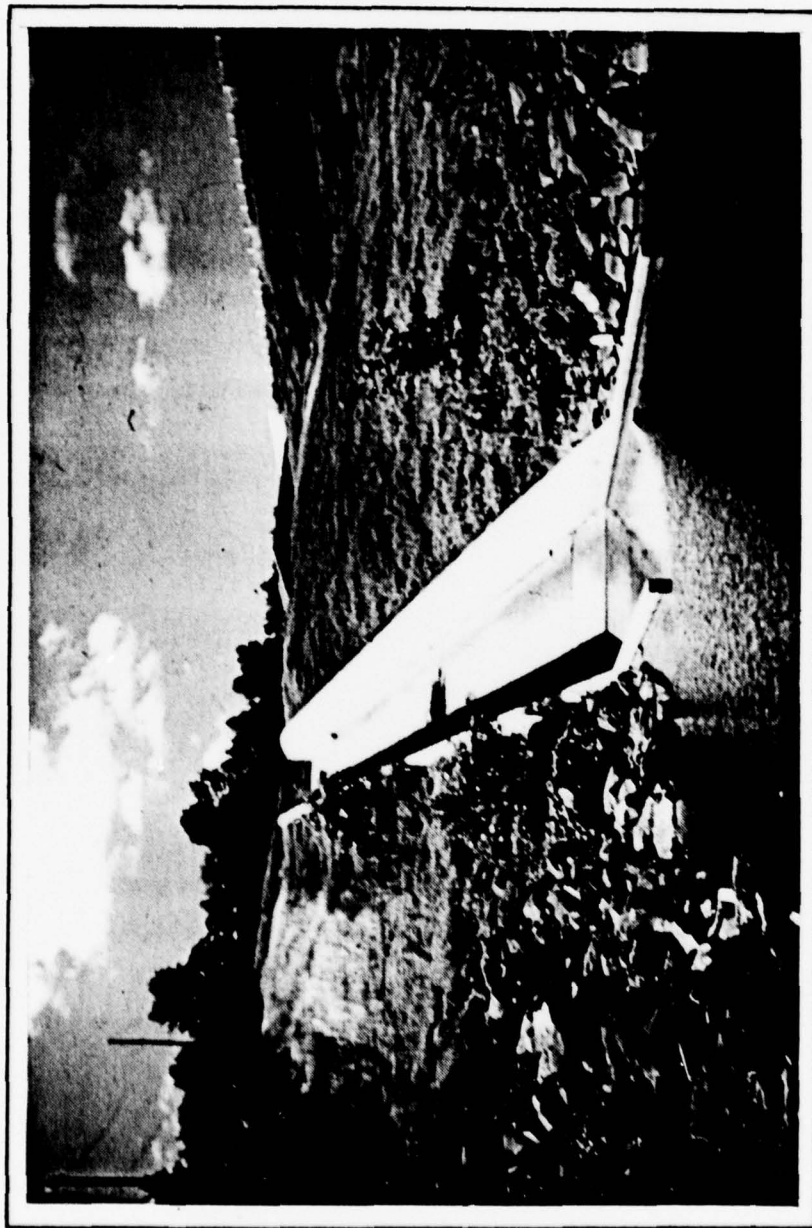
PHOTOGRAPH NO. 5

PRINCIPAL SPILLWAY CHUTE OUTLET AND
STILLING BASIN. CLEAR SEEPAGE DISCHARGES
AT BASE OF CHUTE THROUGH GRAVEL AND PIPES

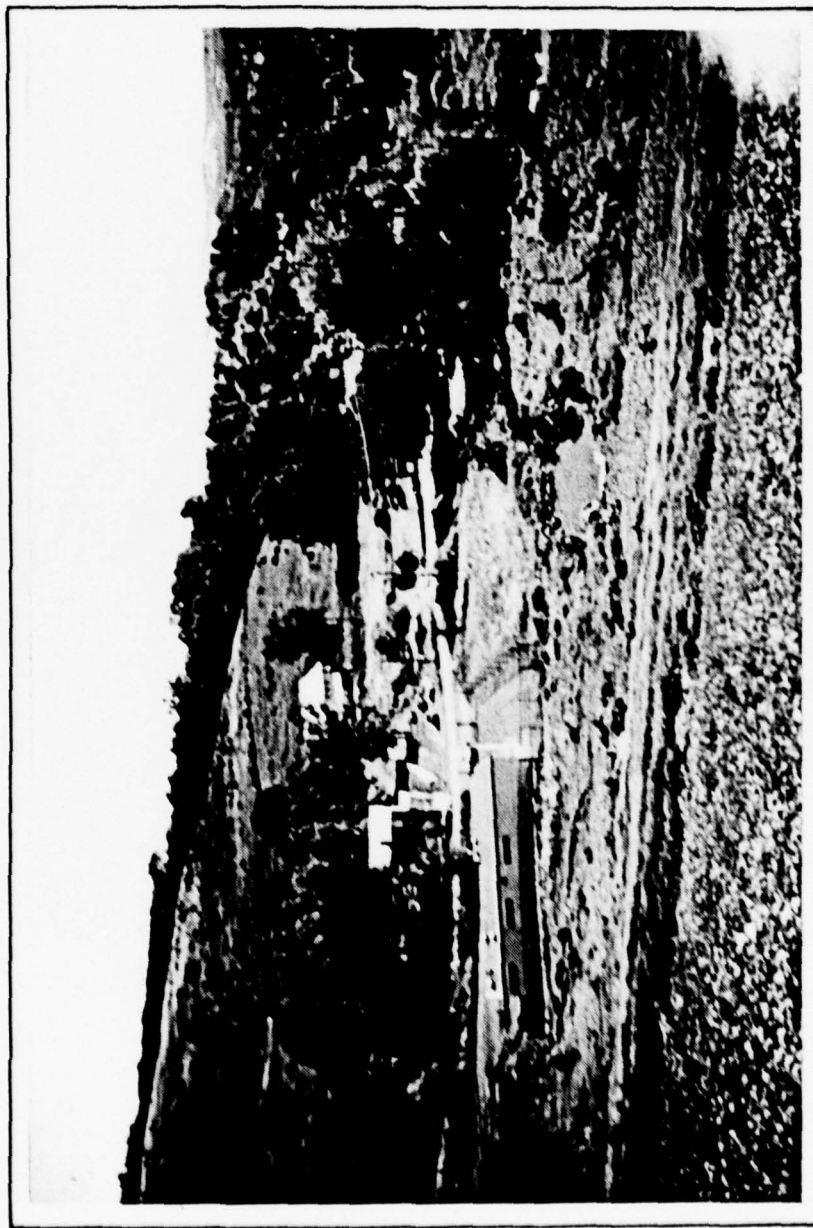
f. Downstream Conditions. Approximately 250 feet downstream from the axis of the dam, discharge flows through a 4.8 by 30 foot bridge under LR 53007. This bridge is expected to be flooded when discharge from the dam is equal to or greater than 1400 cfs. In the immediate area of this bridge are three homes which would be flooded when the depth of flow is 2 feet over the bridge. These three homes and attendant structures together with the sewage plant immediately upstream of the bridge would be destroyed in case of failure.

There are 13 additional homes with several attendant structures in the flood plain of the discharge channel between points A and B as shown in Plate 1. During periods of high flow some of these homes would be damaged and all would suffer at least some damage if the dam failed. Thus, a "High" hazard classification is assigned to this dam.

VIEW LOOKING DOWNSTREAM FROM CREST
OF DAM. NOTE HOMES AND
SEWER PLANT SUBJECT TO FLOODING

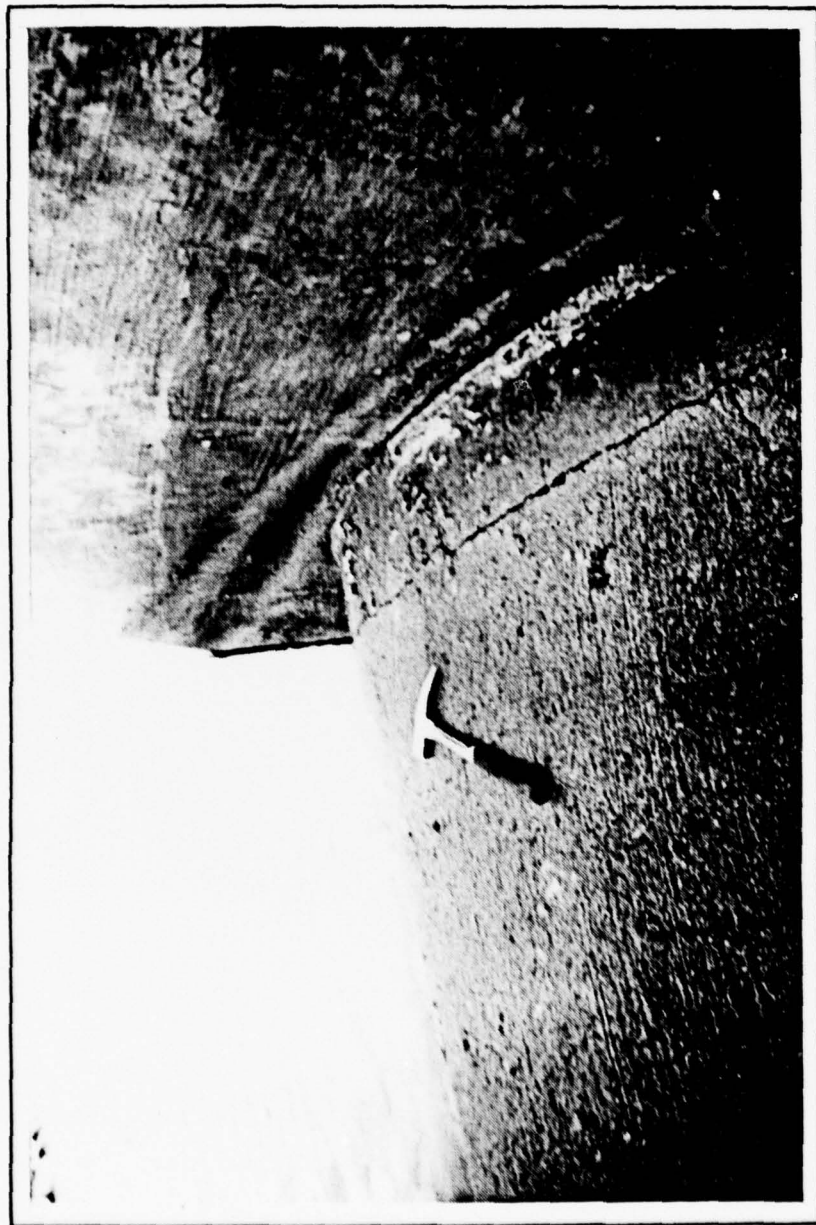
2. Spillway. The spillway weir was observed to be in relatively good condition. However, there were some cracks noted along the left retaining wall and horizontal cracks located along the left side of the weir. Signs of past seepage were noted through many of the cracks. The approach channel retaining walls have rotated. See Photograph No. 8. This movement was observed during a State inspection performed in September, 1977; and the State inspector recommended that the movement be monitored. Along the spillway chute several diagonal cracks and occasional vertical cracks, generally located between construction joints, were observed. Occasional wall rotations were also observed between construction joints. At the base of both chute spillway walls fillet concrete was noted to be deteriorated and broken at several locations. Sections of the fillet concrete up to 2 or 3 feet long were dislocated and scattered along the chute. It is apparent that this fillet was never bonded to the chute slab or the retaining wall or separation cracks were also noted at the base and sides of the fillet along the entire chute.

VIEW OF CRACKED OGEE SECTION
ADJACENT TO LEFT WING WALL.
HORIZONTAL CRACKS WERE NOTED FURTHER
DOWN THE WEIR. NOTE HIGH WATER
MARKS ON THE WINGWALL

5. Cracking noted along the spillway weir should be monitored for seepage. Should seepage be observed, these cracks should be sealed. Similarly, the chute wall cracks should be monitored and cracks sealed if seepage emerges.

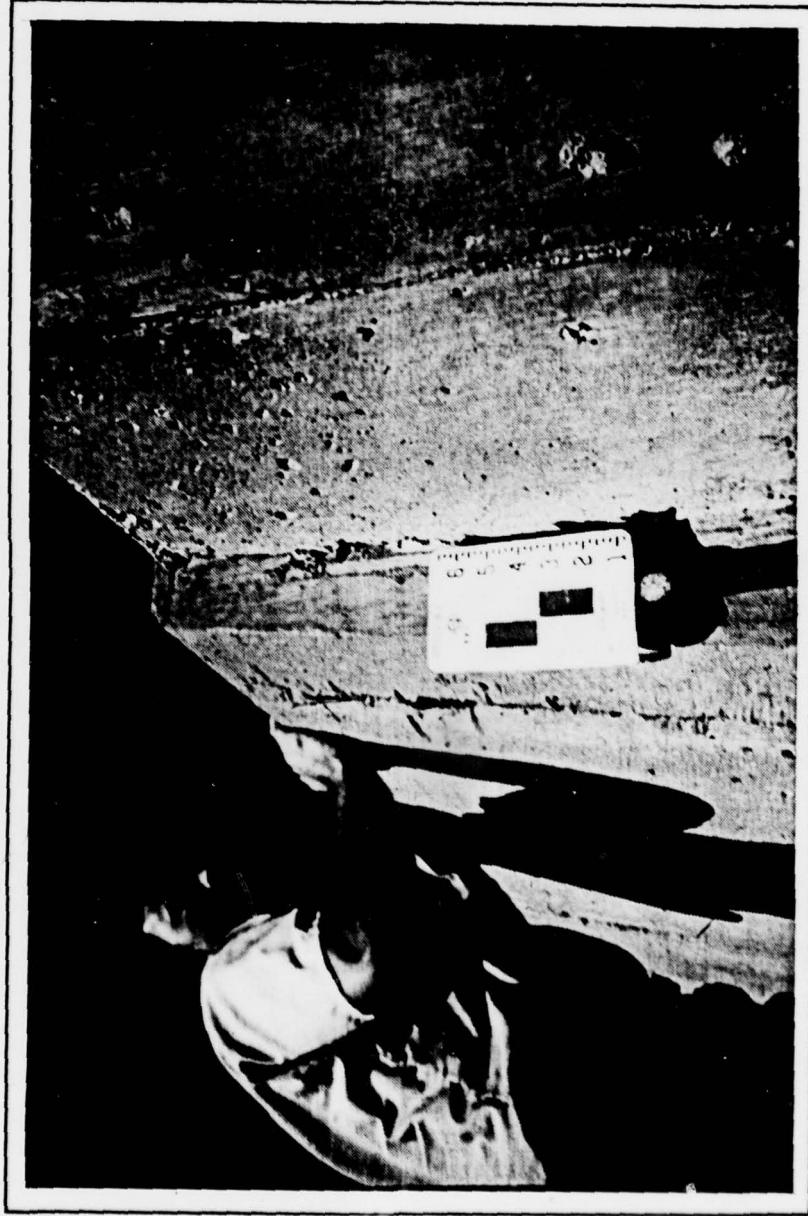
DISPLACED WINGWALL ALONG CHUTE SPILLWAY

3. Rotations noted along the spillway chute retaining walls should be periodically monitored. Should excessive deflections be observed as determined by a registered professional engineer, appropriate remedial measures should be taken.

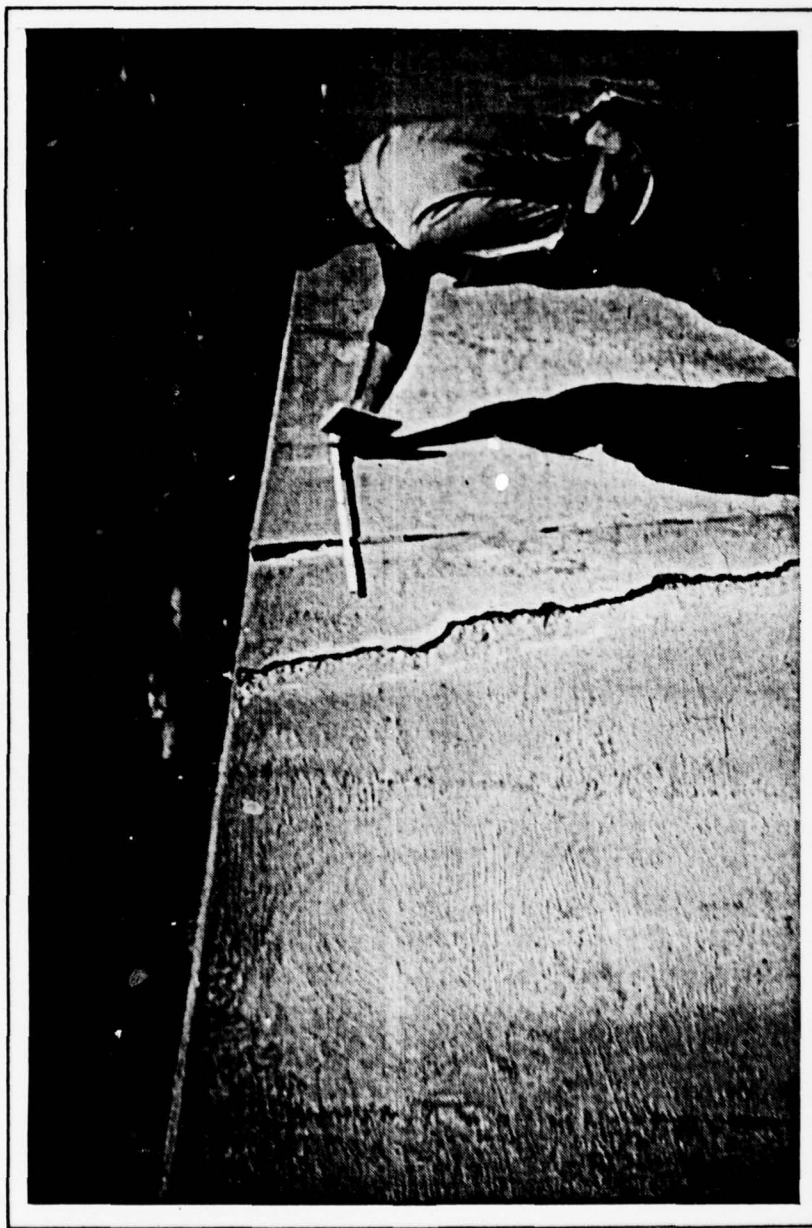
b. Design and Construction Data. Available design data associated with the structural and stability calculations of the spillway were assessed and found to be reasonable. It is noted that there was not enough steel in the spillway walls to prevent shrinkage cracks, but this does not affect the stability of the wall.

CRACKED WINGWALL ALONG SPILLWAY CHUTE

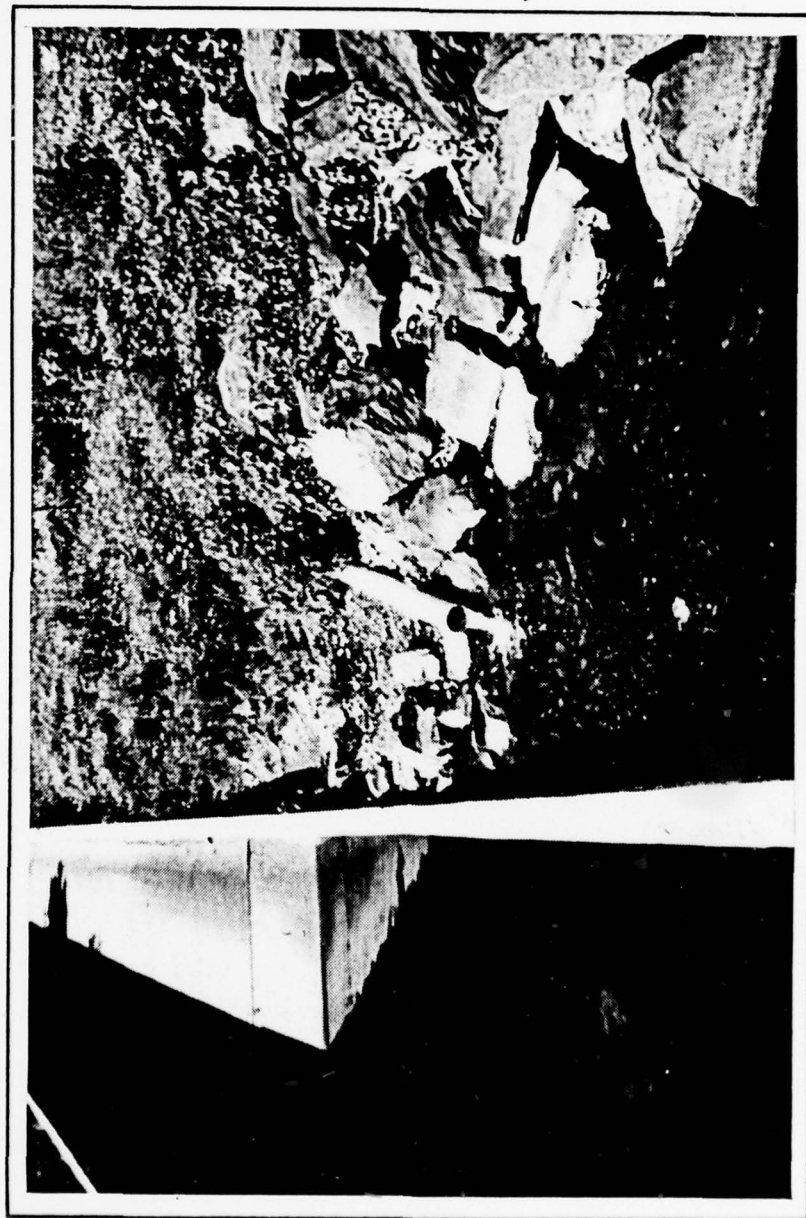
CONTROLLED SEEPAGE THROUGH 6" PLASTIC
PIPE AT BASE OF CHUTE SPILLWAY
(LEFT SIDE). VIEW LOOKING UPSTREAM

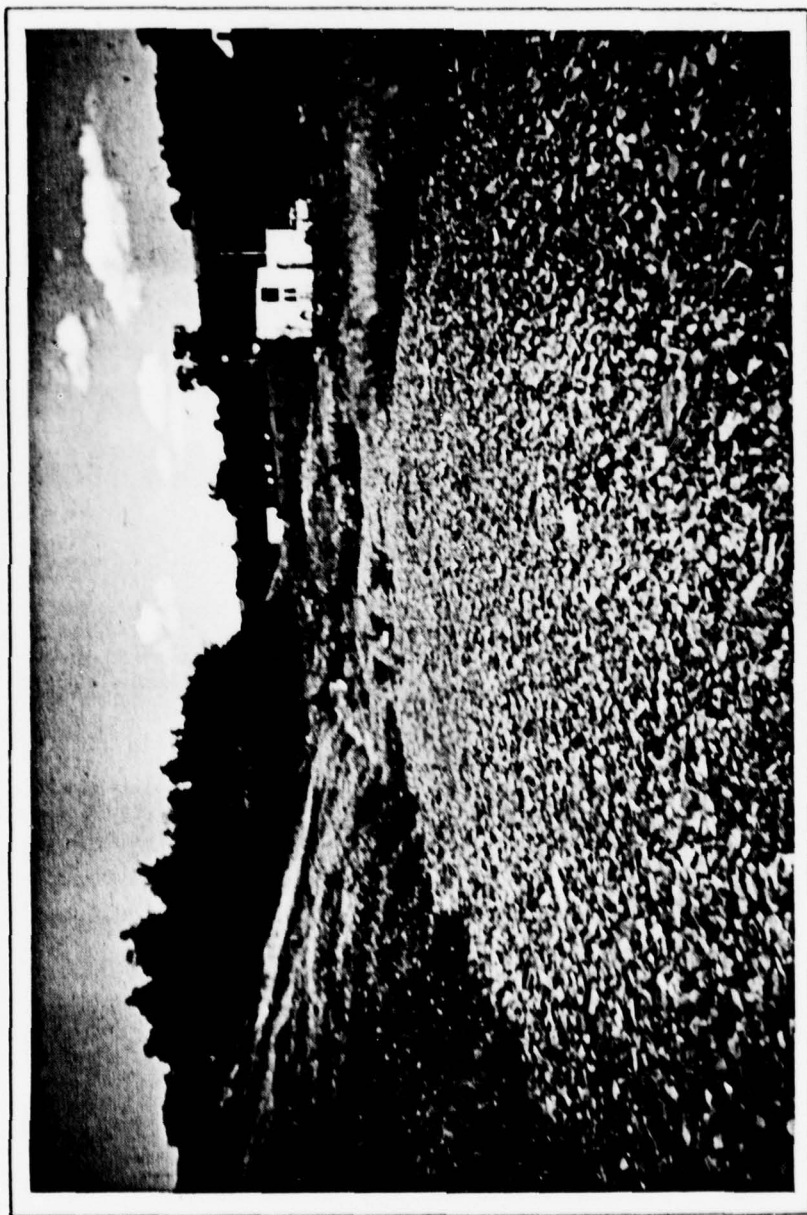
PHOTOGRAPH NO. 12

VIEW OF GRAVEL BLANKET LOOKING
TOWARDS LEFT ABUTMENT AT BASE
OF DAM. NOTE SEWAGE
TREATMENT PLANT IN BACKGROUND

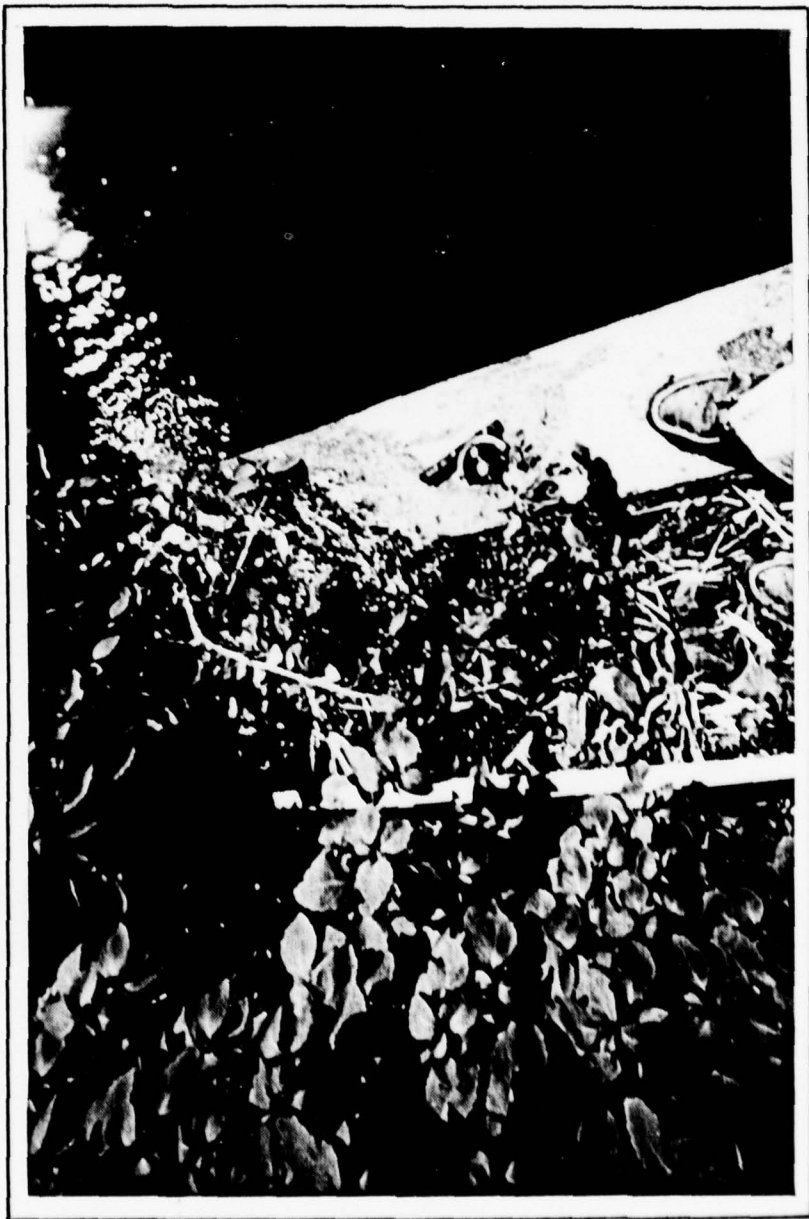
PHOTOGRAPH NO. 13

Seepage was noted along the downstream toe and in other areas beyond the toe were previously inspected and assessed in 1974 to be non-hazardous. This same seepage was noted during this inspection and is qualitatively assessed to be similar to the seepage noted during the previous inspections. Since a comparison of seepage rates over the years has not been made, a firm assessment of the seepage could not be performed.

SEEPAGE THROUGH GRAVEL BLANKET DISCHARGING
OVER LEFT WINGWALL. SEEPAGE IS CLEAR
